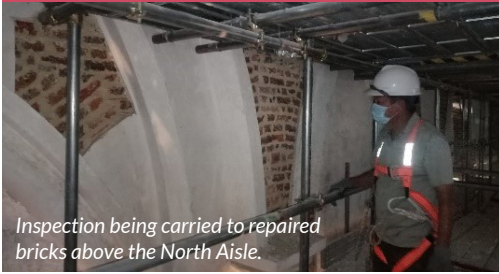
Inspection being carried out to repaired bricks above the North Aisle.
